# FACILITY CONDITION ASSESSMENT

Copeland-Cox Tennis Center

# Facility Condition Assessment

**CBRE Project No.: PC60828394 - 541**

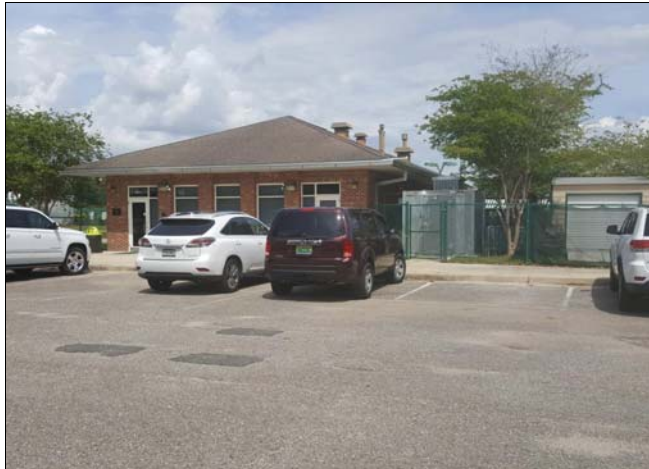
1. Parking lots and roadways are asphalt-paved, and curbs are concrete.

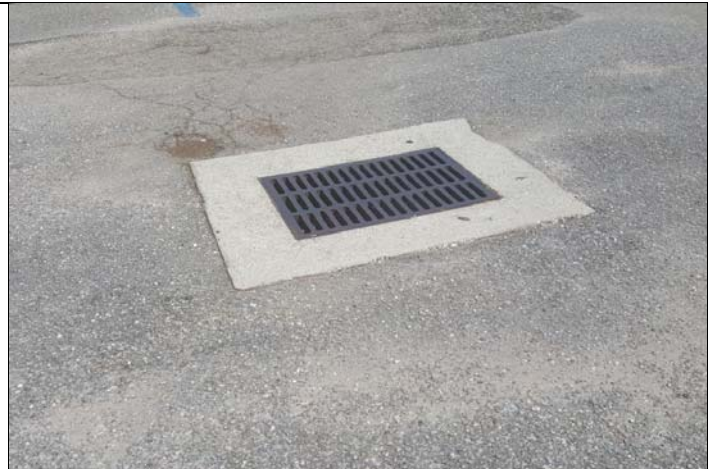
2. There is an interconnected system of storm drain inlets that discharge into the municipal system.

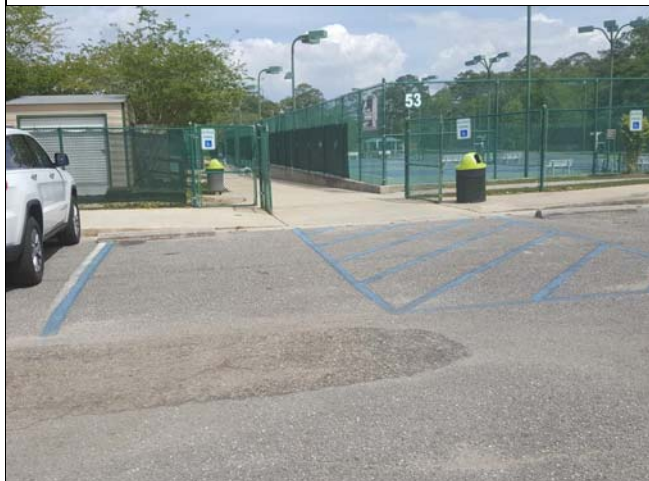
3. Accessible parking spaces are located near the east tennis courts.

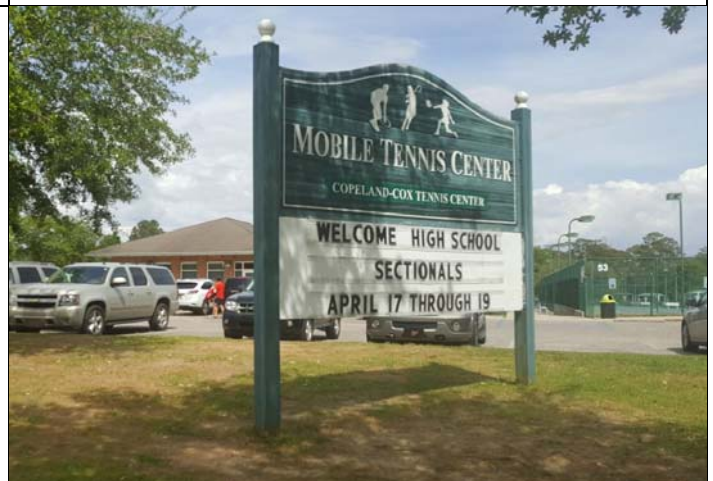
4. A wood sign is provided along Gaillard Drive.

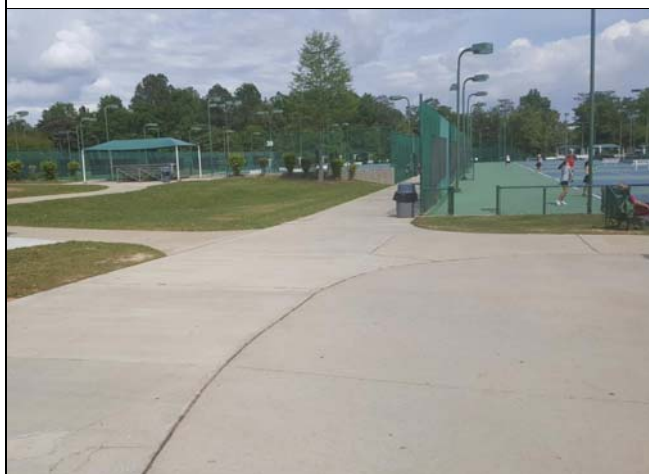
5. Concrete sidewalks connect the tennis courts to the parking areas.

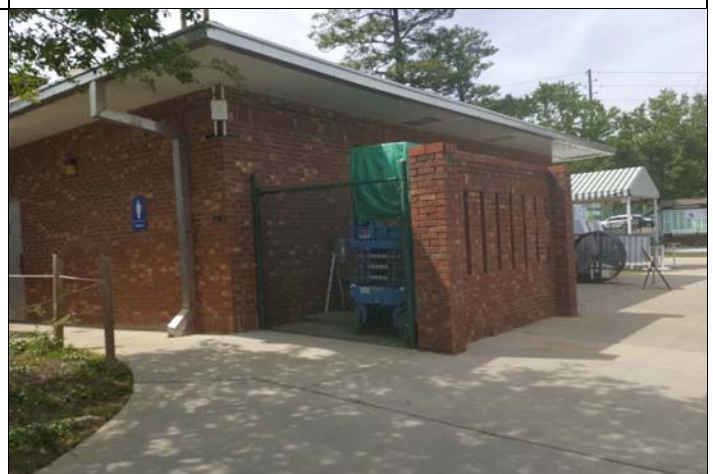
6. The administration building, which has a brick and chain link enclosure.

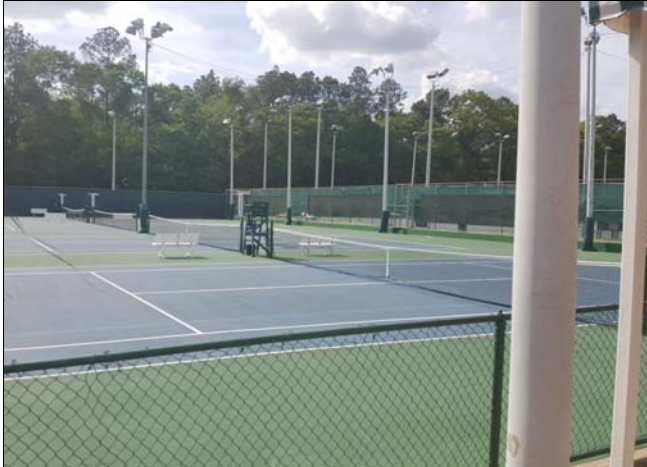
7. There are 60 tennis courts surrounded by chain link fencing. Most site lights were updated within the last two years.

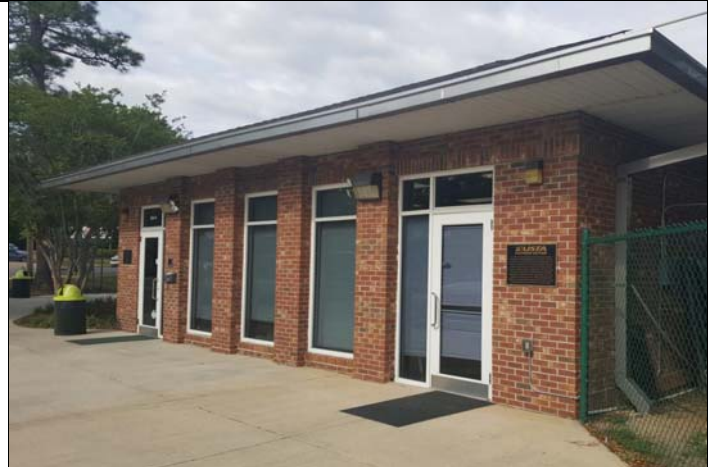
8. The administrative area is one-story, and has brick veneer and aluminum-frame windows.

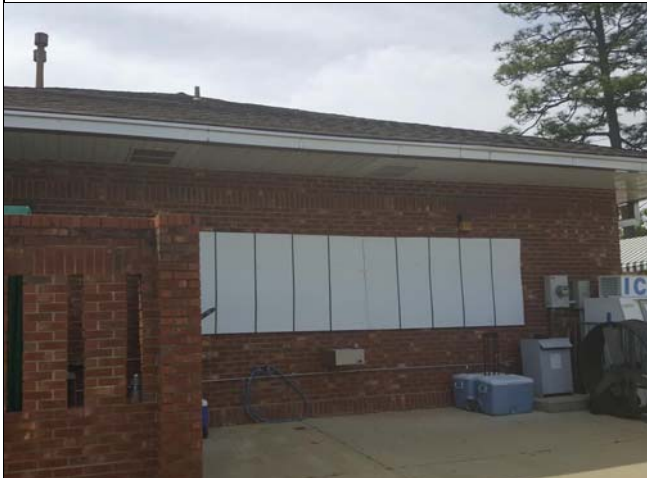
9. The roof is an asphalt shingle system.

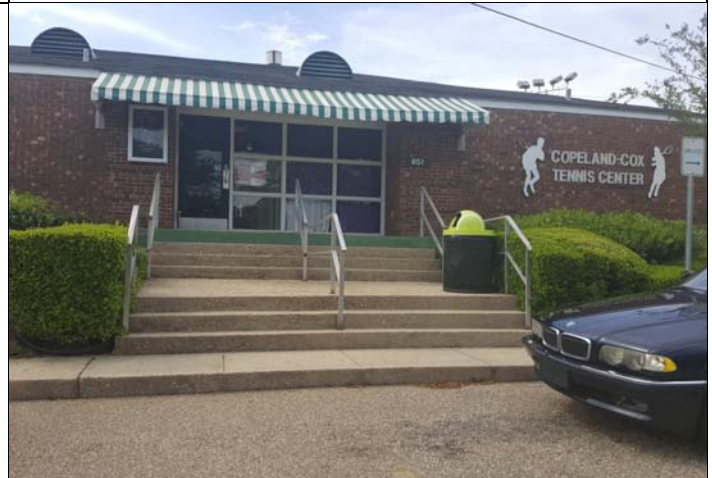
10. The pro-shop and clubhouse is also a one-story building. Signage is mounted on the building.

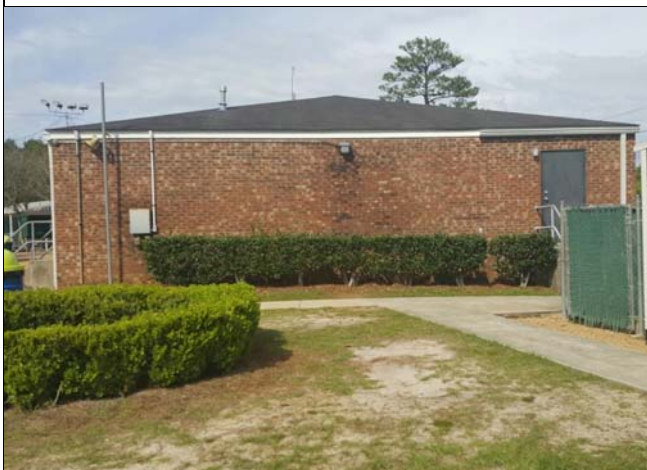
11. The south wall of the pro-shop is also red brick. An asphalt shingle roof is also provided.

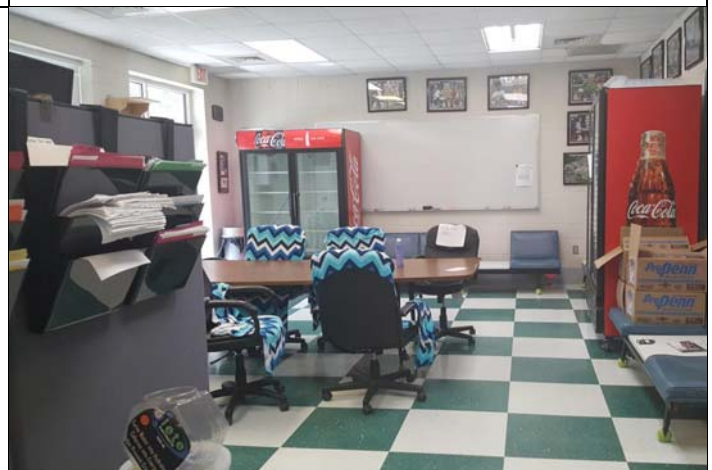
12. The administration area in the east building has office space, a large conference room and support spaces.

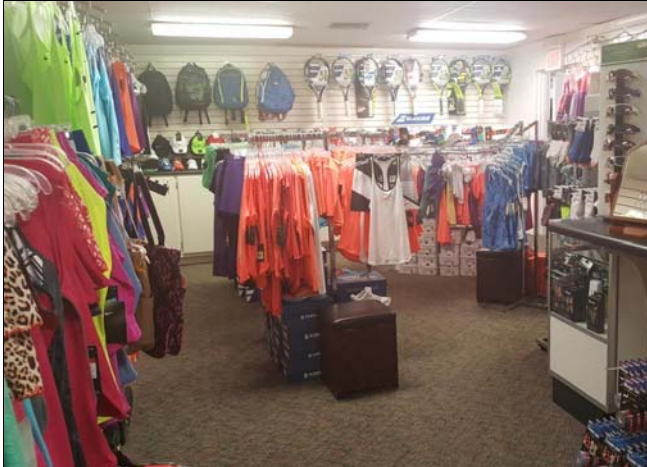
13. The pro shop has a variety of items for sale. Finishes include carpeting, painted walls and shelving systems at the walls.

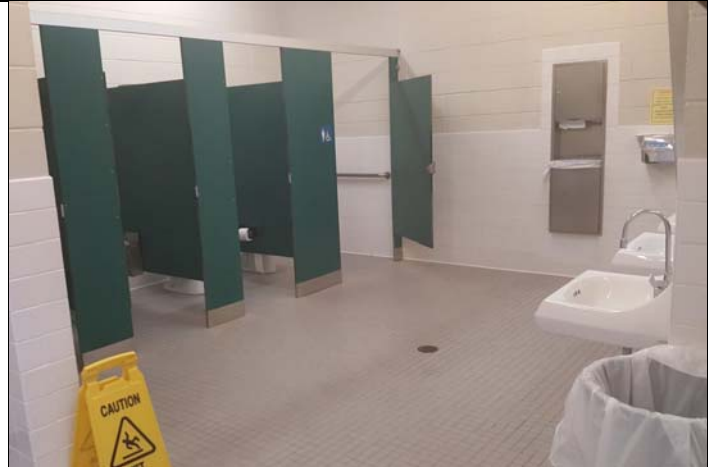
14. Each building has multi-user toilet rooms.

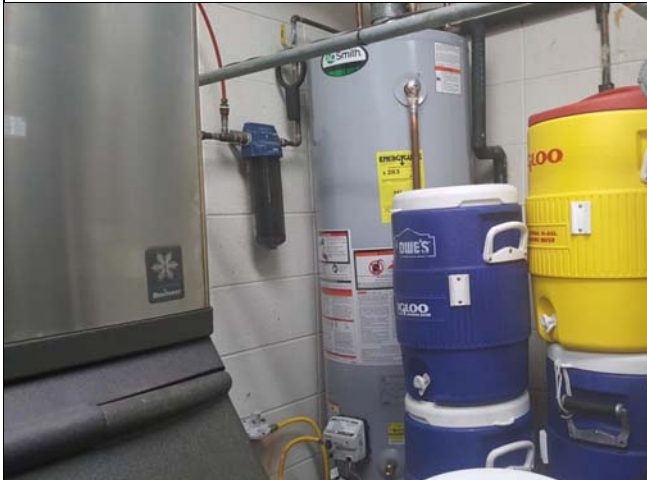
15. A gas-fired domestic water heater serves each of the buildings.

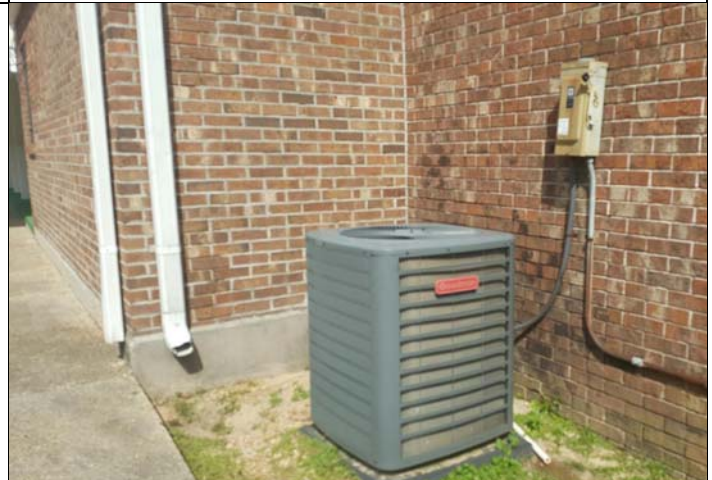
16. Both buildings are heated and cooled by split systems.

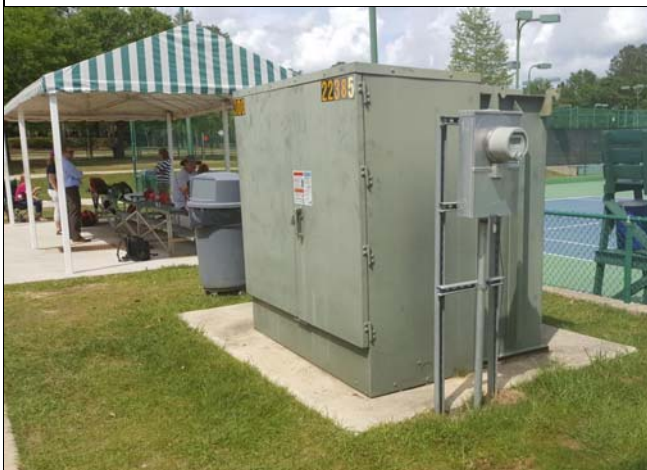
17. A transformer and meter is provided on the east side of the east building.

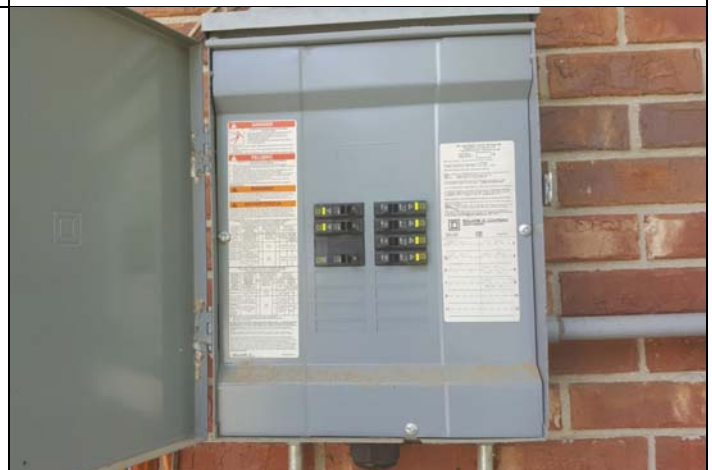
18. Distribution panels are provided as needed throughout the facility.
