# FACILITY CONDITION ASSESSMENT

## City of Mobile

Facility No: 360

Traffic Engineering Office, Sign Shop,  
Warehouse & Storage Buildings

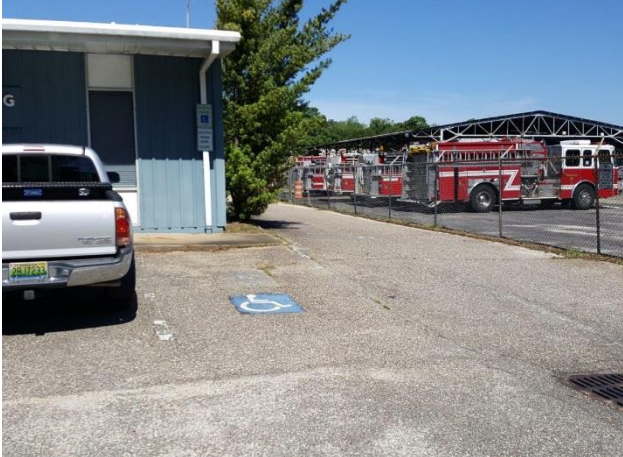
| <p>1. Internal drives and parking areas are paved with concrete.</p> | <p>2. Pavements are drained by inlet drains connected to the municipal system.</p> |

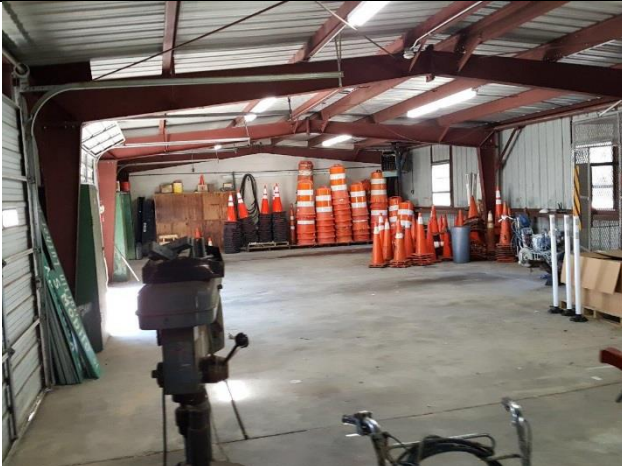
| <p>11. Interior finishes and condition at Vehicle Warehouse building.</p> | <p>12. Domestic hot water for the Office building is generated by a 10-gallon water heater.</p> |

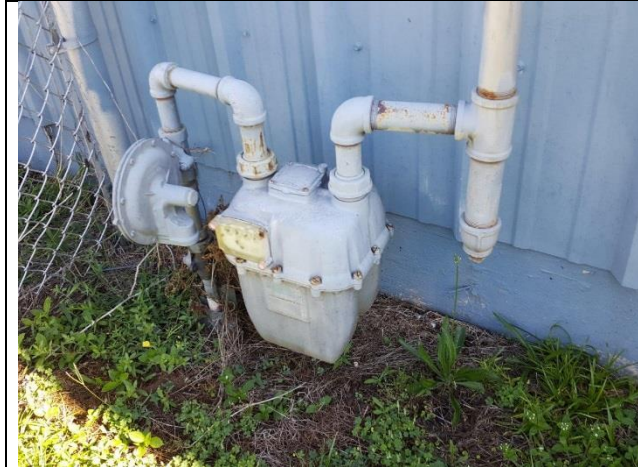
13. Incoming main gas service/meter is located at the south side of the Office building.

| NO. | SECTION # | DESCRIPTION | QUANTITY | UNIT | UNIT COST | OPINIONS OF COST | Deficiency Photo |
|---|---|---|---|---|---|---|---|
| 6 | | <b>Paint Gas Lines</b><br>The gas line exhibits rusting. Wire brush, prime and repaint gas lines at this time. | 1 | MD | \$350.00 | \$350 | |

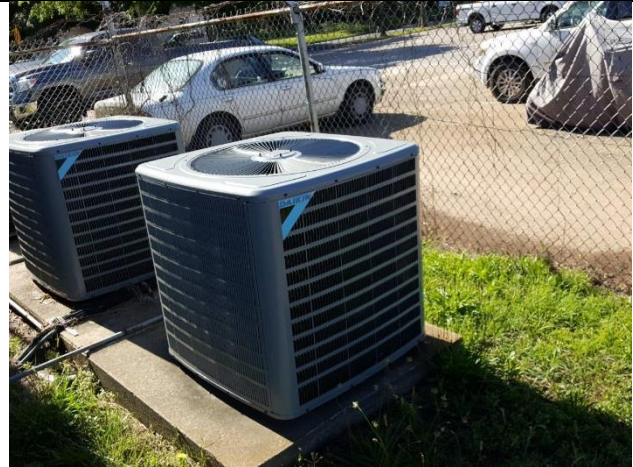
14. Air conditioning and heating at the Office building is provided by split-systems with condensers located on the south side of the building.

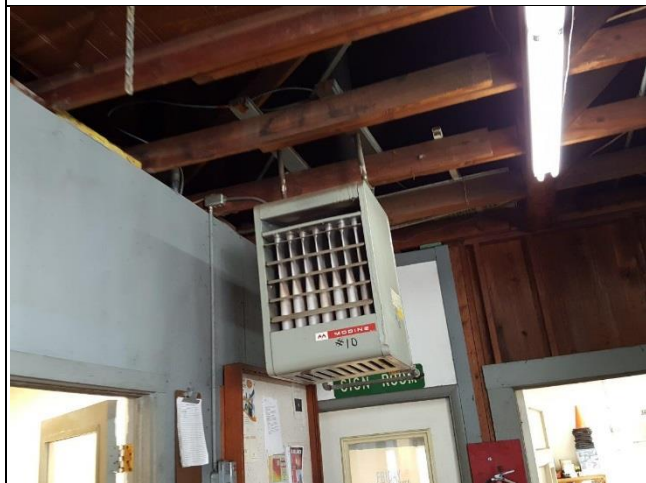
15. Heating at the Sign Shop and Vehicle Warehouse buildings is provided by ceiling hung heaters.

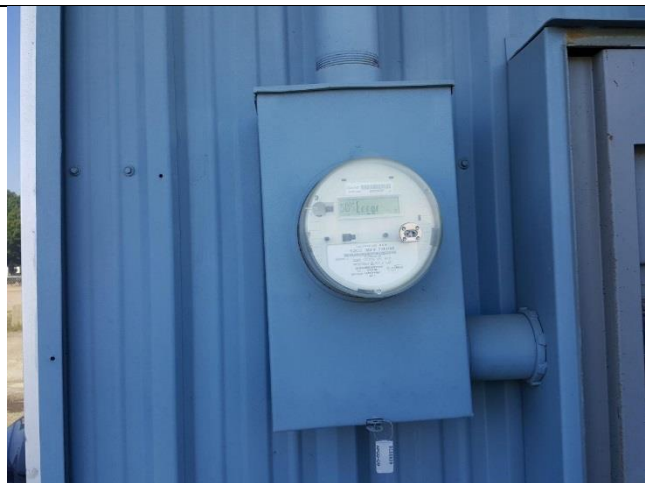
16. The main service panel disconnect switch and meter are located at the southwest corner of the Office building.

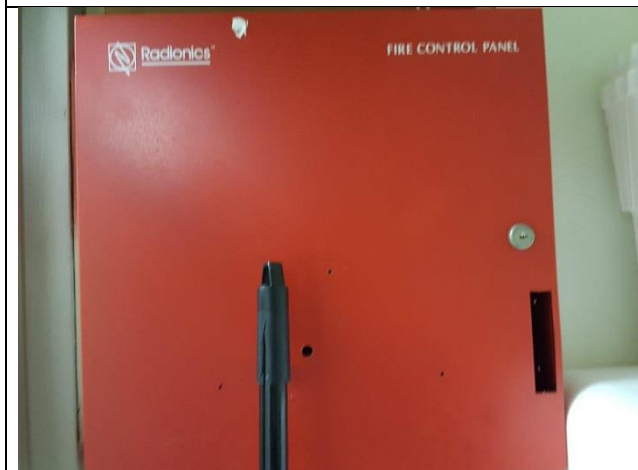
17. Fire protection at the Office building is provided by a fire alarm panel manufactured by Radionics.

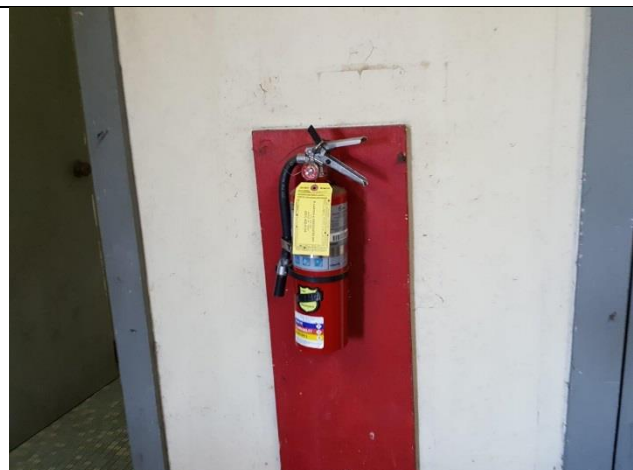
18. Fire protection is provided by wall mounted fire extinguishers.
