# FACILITY CONDITION ASSESSMENT

## City of Mobile

Facility No: 510

Mowing Division Eastern Maintenance

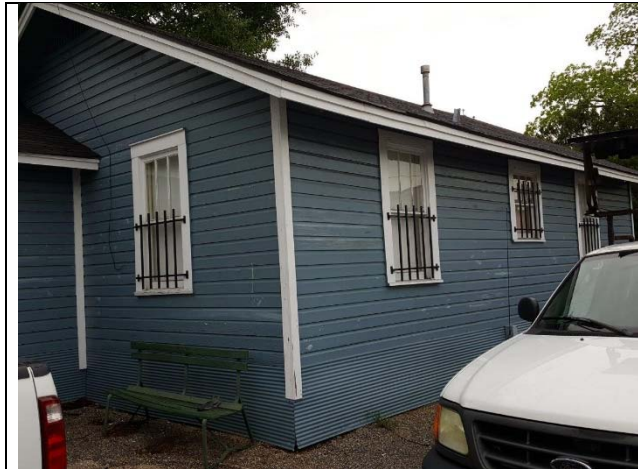
1. View of the Landscaping Services building.

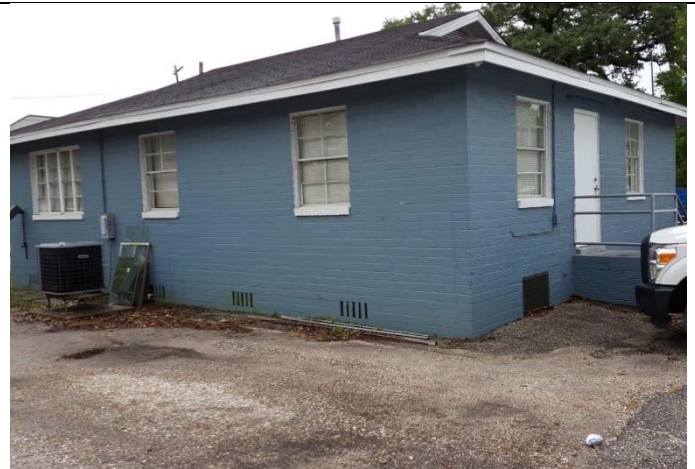
2. View of the Eastern Maintenance building.

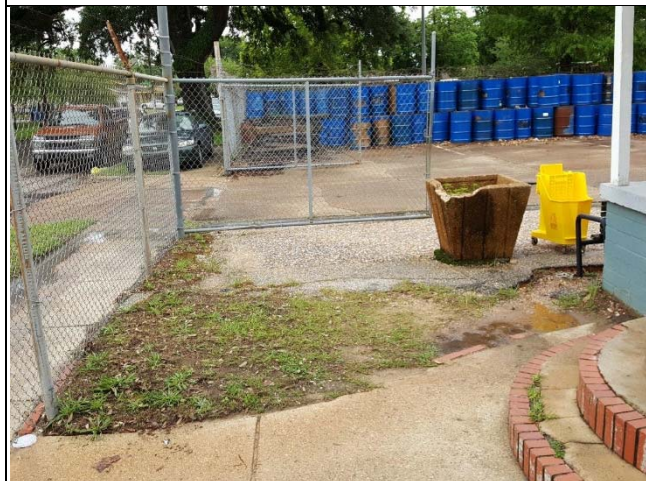
3. South Jefferson street entrance and concrete paved parking areas at the south side of the Eastern Maintenance building.

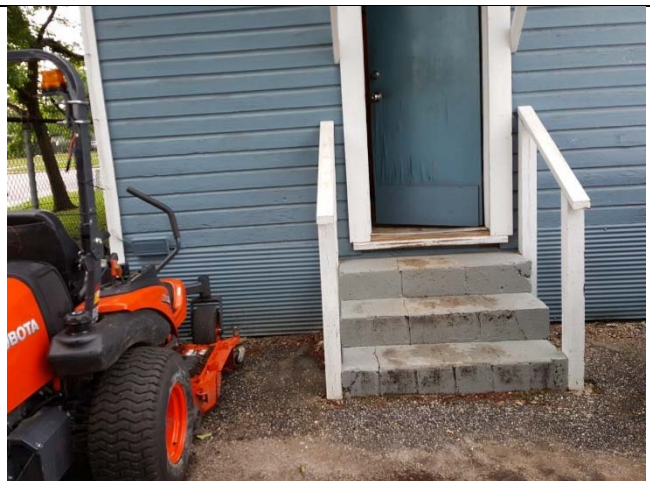
4. Entrances to both buildings is via exterior steps.

| NO. | SECTION NO. | DESCRIPTION | QUANTITY | UNIT | UNIT COST | OPINIONS OF ADA COST | Deficiency Photo |
|---|---|---|---|---|---|---|---|
| 1 | | <b>Construct New Concrete ADA Ramp</b><br>Presently, access to both building entrances is via several exterior steps. Access for persons with disabilities is not provided for. A new ADAAG compliant concrete ramp system should be installed with pipe railings. | 2 | CD | \$5,000.00 | \$10,000 | |

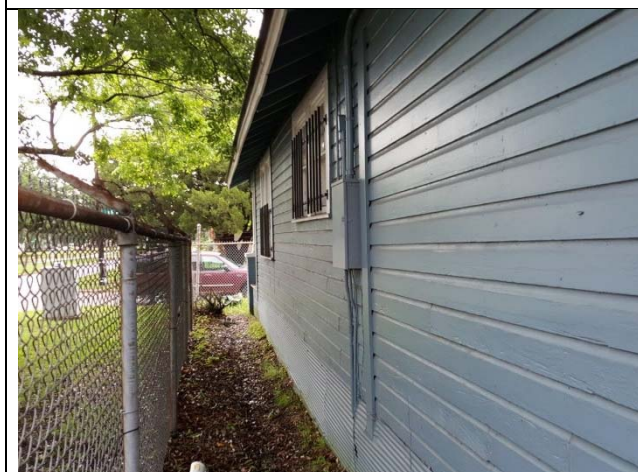
5. Exterior sidewall system at the Landscaping Services building consists of painted wood siding.

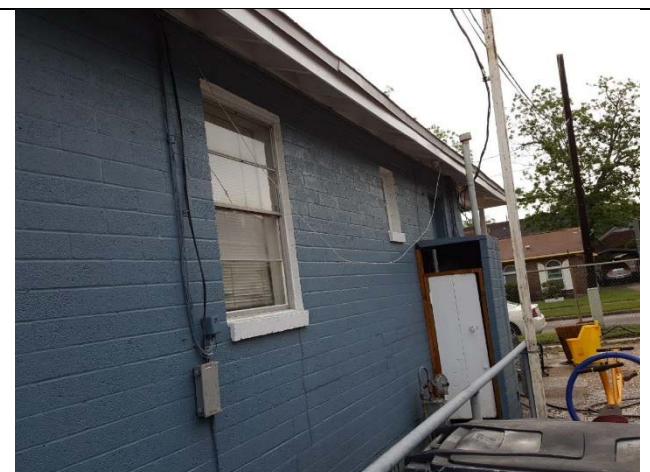
6. Exterior sidewall system at the Eastern Maintenance building consists of painted brick.

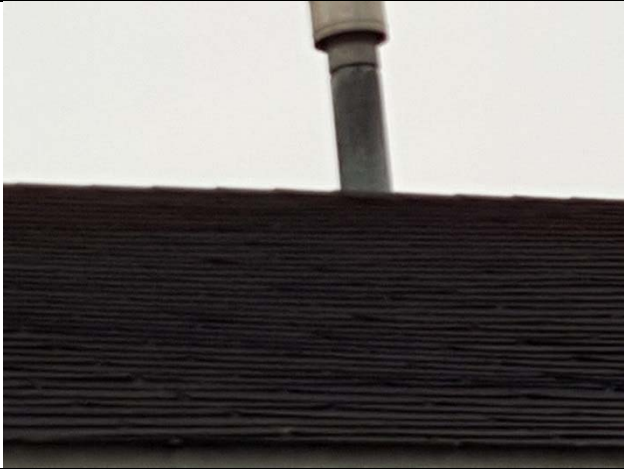
| <p>7. Both buildings are provided with asphalt shingle roofing system.</p> | <p>8. Interior finishes and condition at the Landscaping Services multiuse/meeting room.</p> |

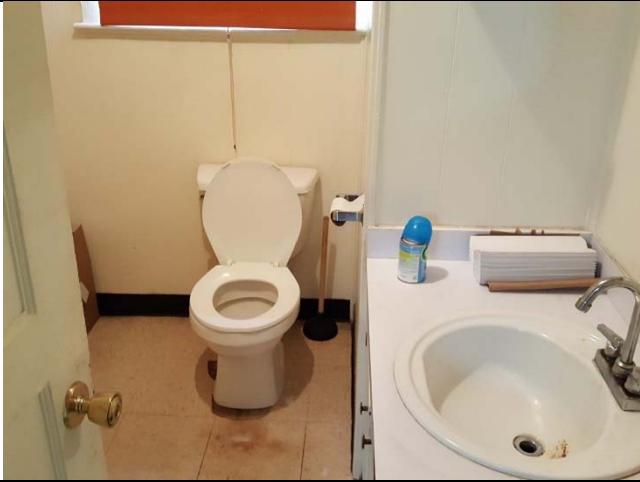
| <p>9. Toilet room fixtures and finishes at the Landscaping Services building.</p> | <p>10. Interior finishes and condition at the Eastern Maintenance multiuse/meeting room.</p> |

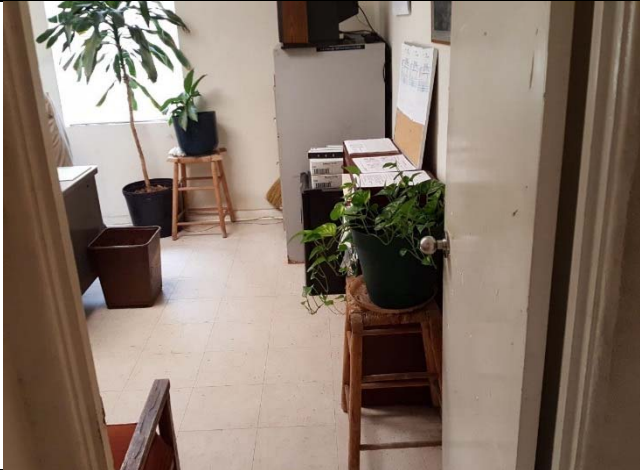
| <p>11. Office interior finishes and condition at the Eastern Maintenance Building.</p> | <p>12. Toilet room interior fixtures and finishes at the Eastern Maintenance building.</p> |

| NO. | SECTION # | DESCRIPTION | QUANT | UNIT | UNIT COST | OPINIONS OF COST | Deficiency Photo |
|---|---|---|---|---|---|---|---|
| 2 | 3.1 | <b>Interior Upgrade - Eastern Maintenance Building</b><br>The Eastern Maintenance building interior finishes were observed to be in poor condition including damaged/missing VCT floor tiles, peeling and deteriorated wall paint, stained ceilings, and isolated cracked gypsum board walls. A complete interior upgrade of the interior finishes is recommended at this time. | 1,000 | SF | \$35.00 | \$35,000 | <br><br> |

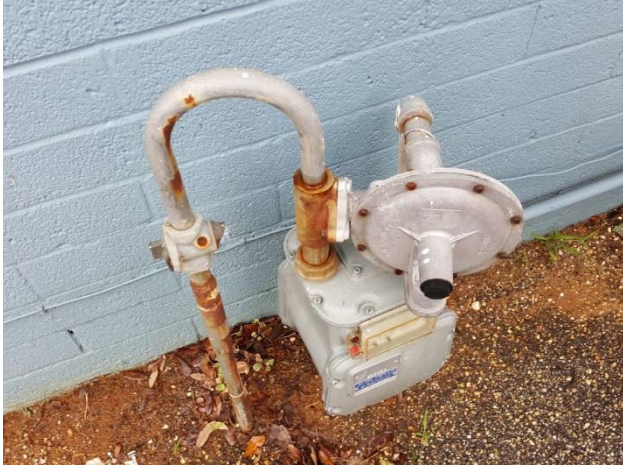
13. Independent natural gas lines and meter are provided at each building.

| NO. | SECTION # | DESCRIPTION | QUANT | UNIT | UNIT COST | OPINIONS OF COST | Deficiency Photo |
|---|---|---|---|---|---|---|---|
| 4 | | <b>Paint Rusted Gas Line and Meter</b><br>The gas line and meter serving the Eastern Maintenance building exhibits rust. Wire brush, prime and repaint gas line and meter at this time. | 1 | MD | \$350.00 | \$350 | |

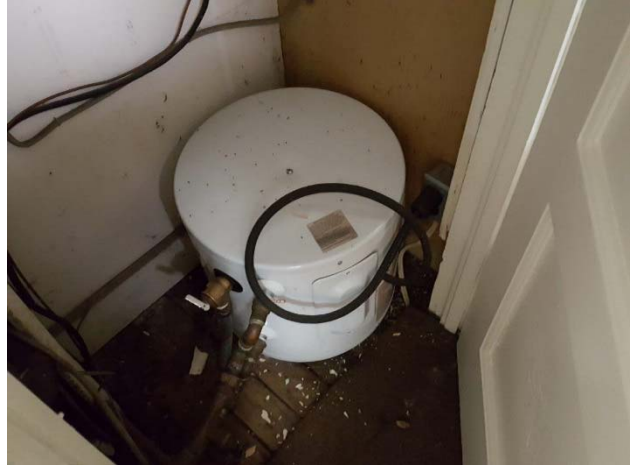
14. Domestic hot water at the Landscaping Services building is generated by an electric resistance DWH.

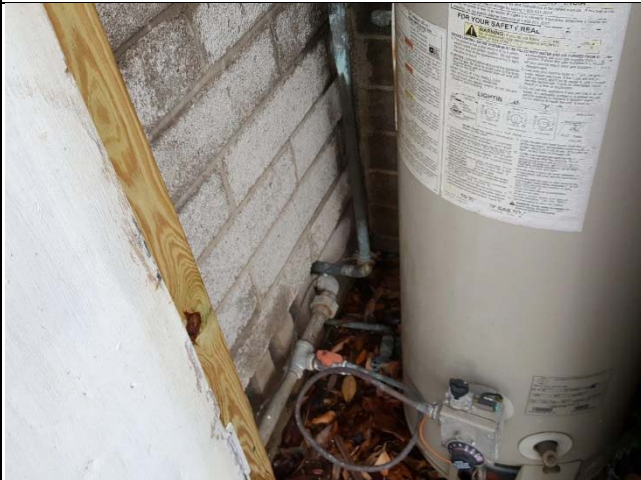
15. Domestic hot water at the Eastern Maintenance Building is generated by a gas-fired DWH.

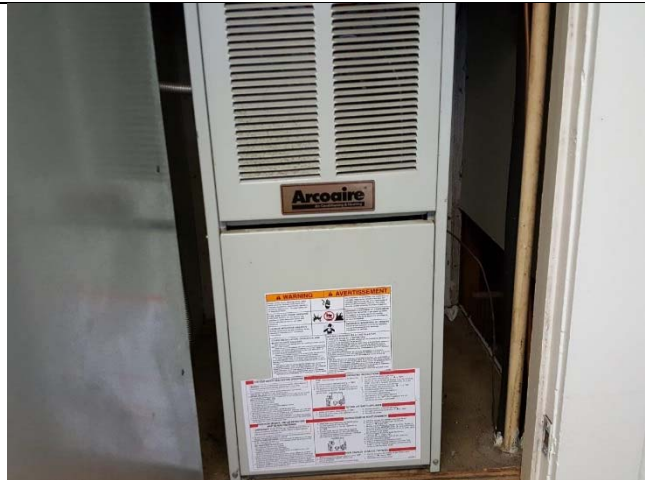
16. Air conditioning is provided by split systems with AHU's located inside the building.

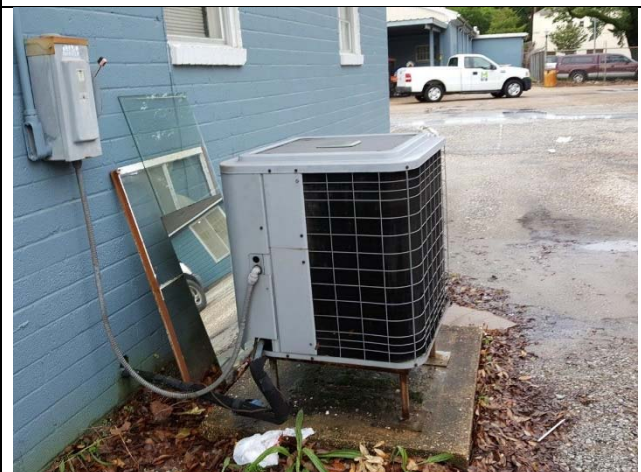
17. Condensers are located outside the building.

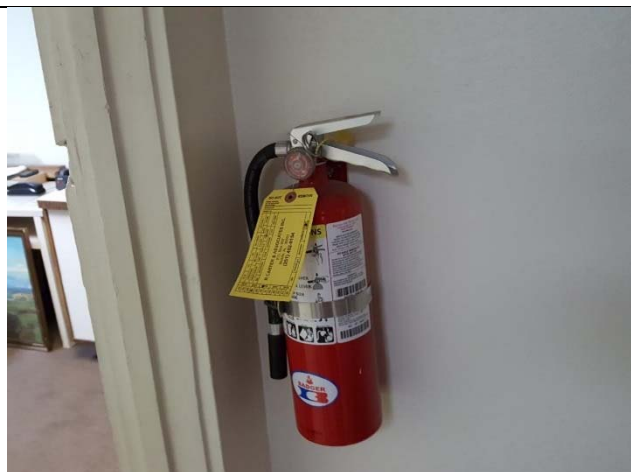
18. Fire protection is provided by wall mounted fire extinguishers.

| NO. | SECTION # | DESCRIPTION | QUANT | UNIT | UNIT COST | OPINIONS OF COST | Deficiency Photo |
|---|---|---|---|---|---|---|---|
| 8 | | <b>Pressure Test and Re-Tag Fire Extinguishers</b><br>Many of the on-site fire extinguishers were found to have expired inspection tags or to be not fully charged. Each fire extinguisher should be pressure tested, re-charged (if needed) and re-tagged. | 2 | EA | \$50.00 | \$100 | |
