# FACILITY CONDITION ASSESSMENT

Quigley House – Distinguished Young  
Women (DYW)

751 Government Street  
Mobile, Alabama 36602

# Facility Condition Assessment

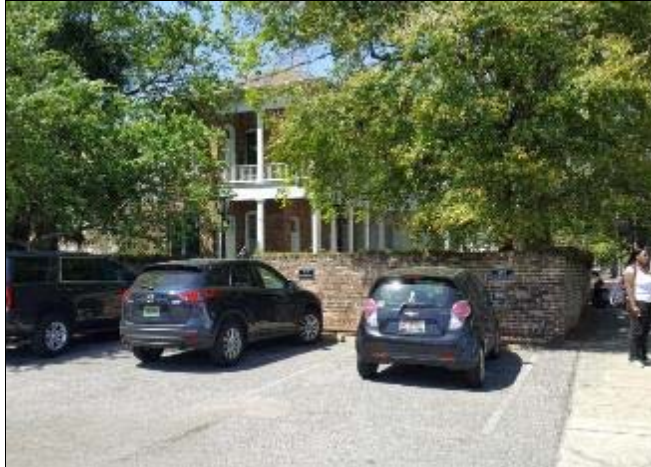
1. The pavement is asphalt with wheel stops but no curbing. The lot is shared with an adjacent building.

| NO. | SECTION # | DESCRIPTION | QUANTITY | UNIT | UNIT COST | OPINIONS OF COST | Deficiency Photo |
|---|---|---|---|---|---|---|---|
| 3 | | <b>Striping, 4" Wide - Layout and Application</b><br>The parking stalls, handicapped parking markings and driveway directional arrows were noted to be faded and worn. All affected areas should be re-striped to improve curb appeal. | 11 | EA | \$9.00 | \$99 | |

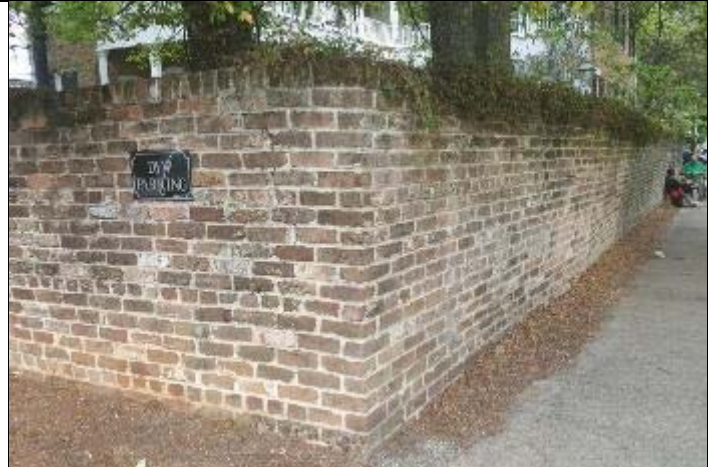
2. The courtyard is surrounded by a brick wall with cast iron gates.

| NO. | SECTION # | DESCRIPTION | QUANTITY | UNIT | UNIT COST | OPINIONS OF COST | Deficiency Photo |
|---|---|---|---|---|---|---|---|
| 2 | | <b>Rebuild Historic Brick Wall Around Courtyard</b><br>There is a 4' tall historic brick wall around the courtyard area on the east, south and partial west sides of the Subject. The wall appears to be in a state of failure along the east and west sides as evidenced by extensive cracking and visible outward rotation. The wall is reported to be a triple wythe brick wall with a cast stone cap. Costs include complete rebuilding of the failed wall system and reinforcement of the remainder. | 185 | LF | \$65.00 | \$12,025 | |

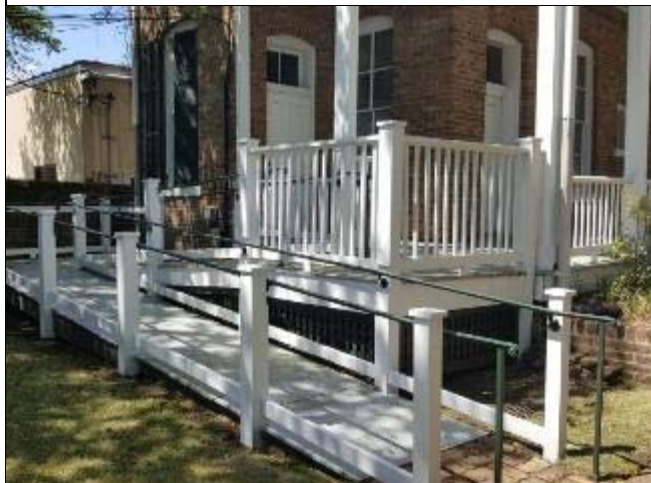
3. A wooden ramp system provides access to the first level from the rear courtyard.

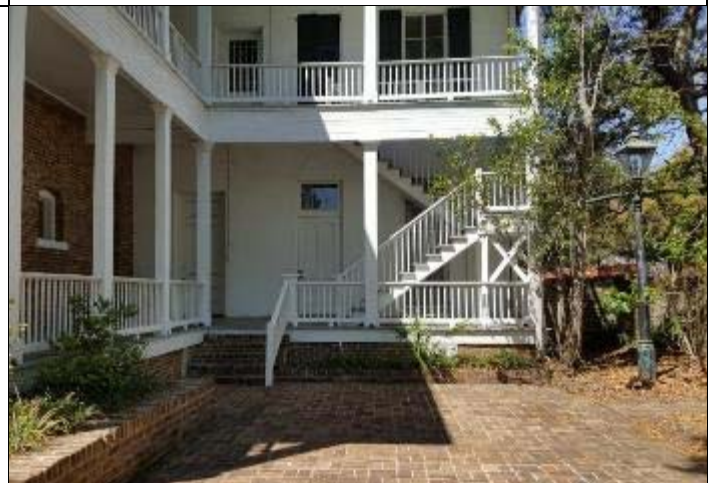
4. A landscaped brick-paved courtyard is provided at the rear of the building.

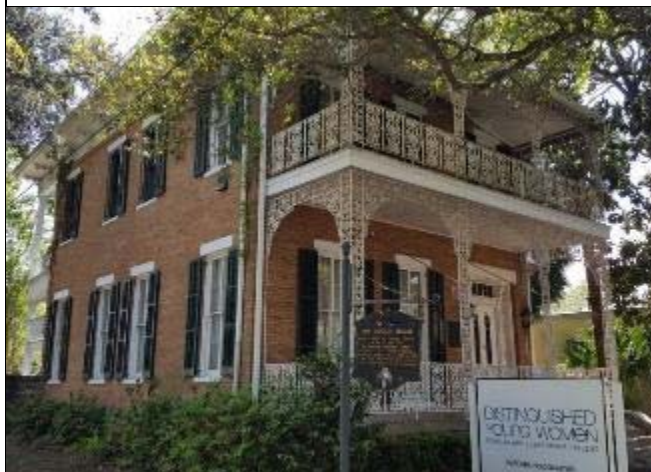
5. The main façade faces Government Street and has brick veneer and cast iron decorative metal railings at the upper and lower balconies.

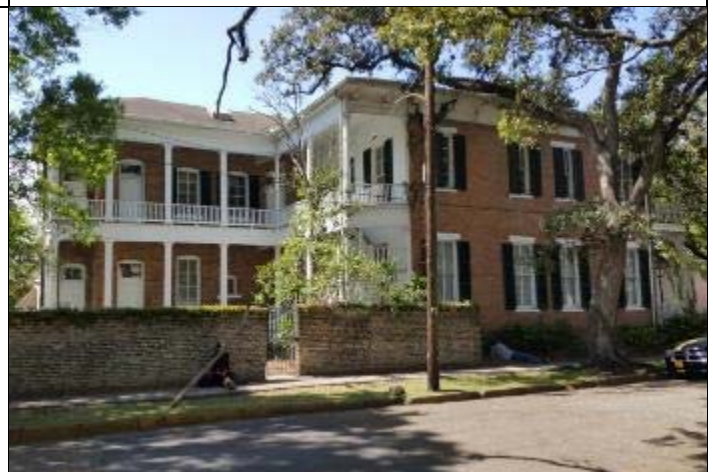
6. The east facing elevation has brick, stucco and wood framed balconies at the ground and upper level.

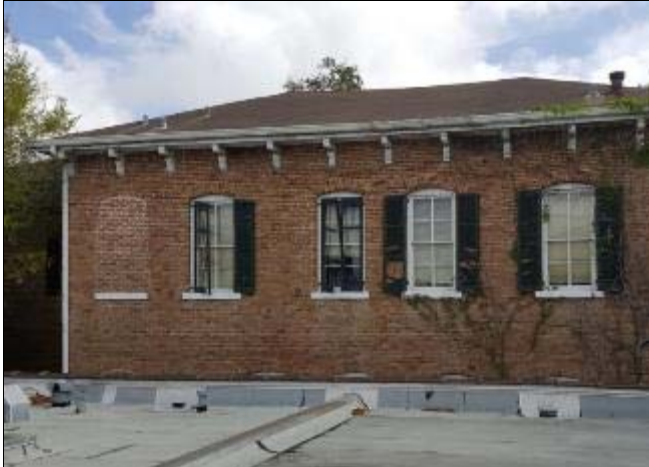
7. The west elevation is also brick. The windows have decorative shutters. The roof system is asphalt shingles drained by gutters and downspouts.

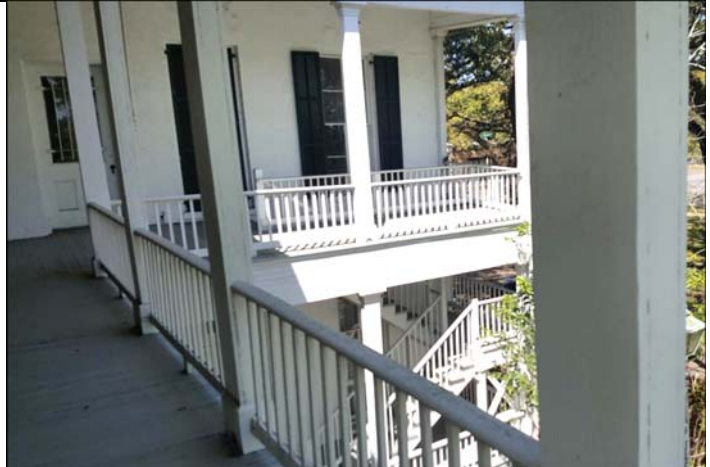
8. The balconies are wood framed structures with painted wood decking and railings.

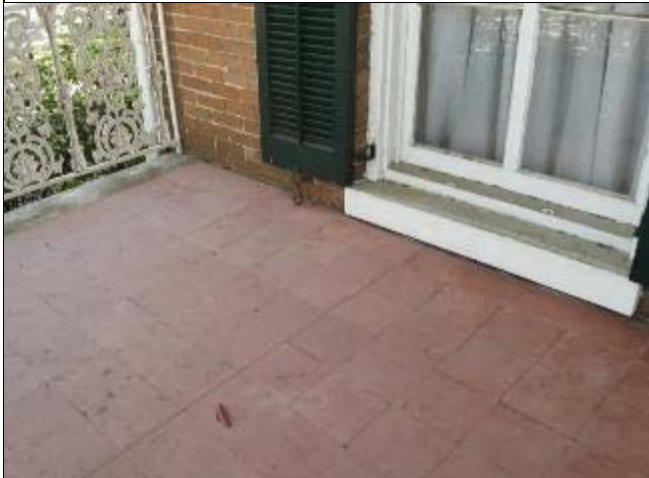
9. The front porch has ceramic tile, wood sills at the windows, shutters and decorative iron railings.

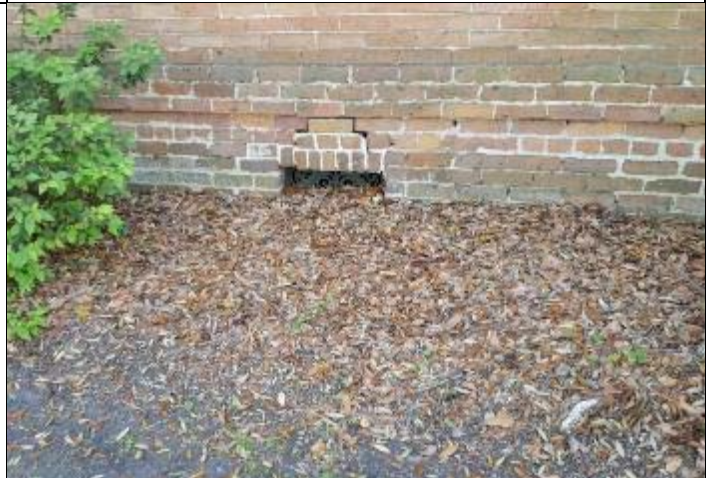
10. The structure is conventional wood framing with a crawl space.

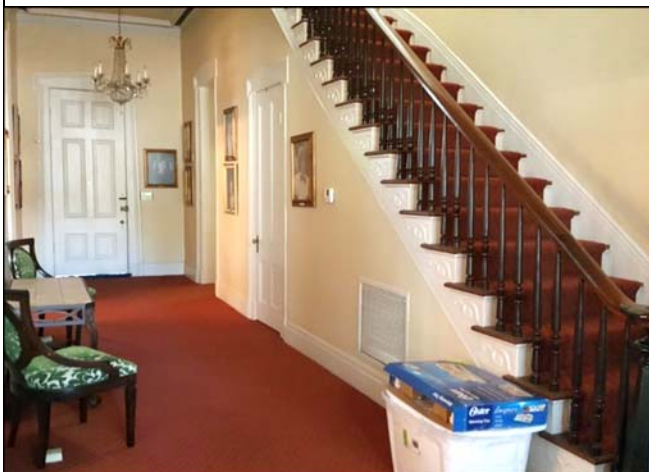
11. The central hallway maintains the original residential character of the building with a grand stairway.

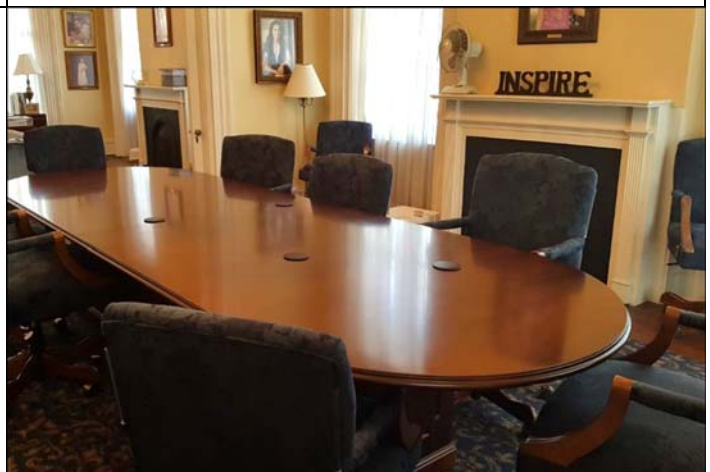
12. The rooms on either side of the central hallway area are offices and conference rooms.

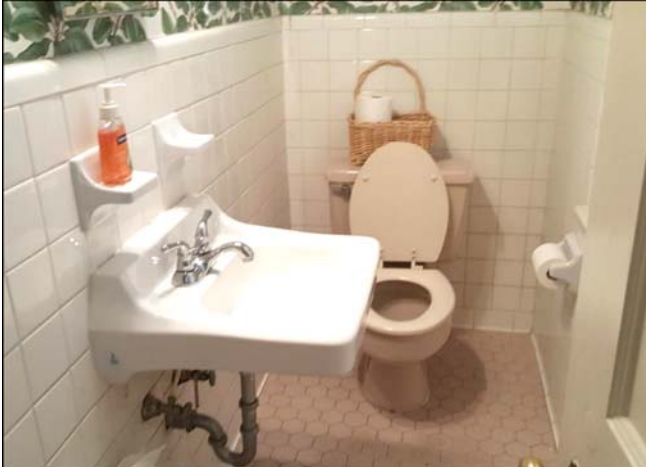
13. Two small single user toilets are provided on the first floor. A similar set of toilets is located on the second floor as well.

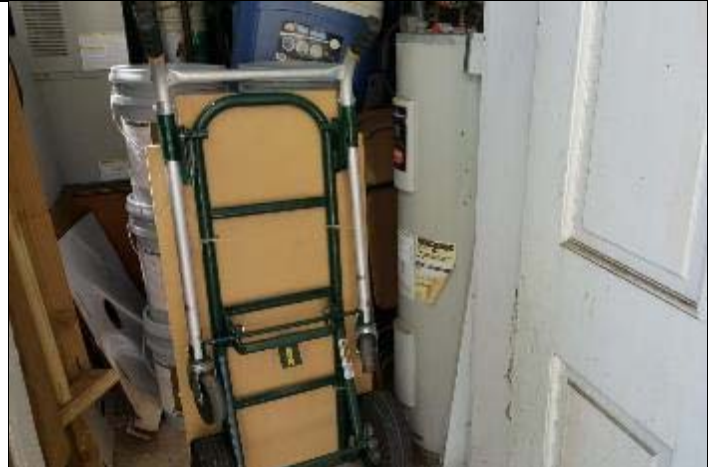
14. Hot water is provided by a 30-gallon Bradford White electrical resistance DWH located in a mechanical/ storage room.

| COMPONENT OR SYSTEM | AVG<br>EUL<br>(Yr) | EFF<br>AGE<br>(Yr) | RUL<br>(Yr) | QUANTITY | UNIT | UNIT<br>COST<br>(\$) | CYCLE<br>REPLMNT<br>COST | PROBABLE REPLACEMENT DATES & ESTIMATED EXPENDITURES (\$) | | | | | | | | | | | | Total<br>Reserve<br>Item |
|---|---|---|---|---|---|---|---|---|---|---|---|---|---|---|---|---|---|---|---|---|
| Replace Individual Tank Type DWHs | 15 | 13 | 2 | 1 | EA | 2,500.00 | 2,500 | 0 | 2,500 | 0 | 0 | 0 | 0 | 0 | 0 | 0 | 0 | 0 | 0 | 2,500 |

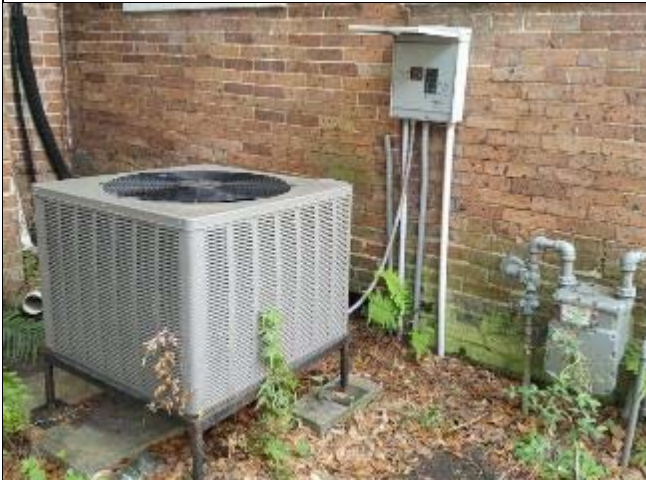
Air conditioning and heating is provided by one 4-ton Heil package unit and three split systems. The Heil unit has reached its EUL, and the split systems are various ages and manufacturers, though generally they are 3 tons each and about 10 years old.

15. The building is heated and cooled by split systems with condensers and a package unit located on the west side of the building.

| NO. | SECTION # | DESCRIPTION | QUANTITY | UNIT | UNIT COST | OPINIONS OF COST<br>SHORT TERM | Deficiency Photo |
|---|---|---|---|---|---|---|---|
| 10 | | <b>Replace HVAC Package Unit Serving the Front (North) Offices</b><br>The Heil package unit serving the front offices is reported to be serviced every 3 months or so and appears to be at the end of its EUL. Additionally, we recommend providing additional cooling based on 150 SF per ton, which indicated the cooling capacity may be slightly below standards. Replacement is warranted at this time. It was indicated that grant funds may be available for this work. | 5 | TONS | \$1,200.00 | \$6,000 | |

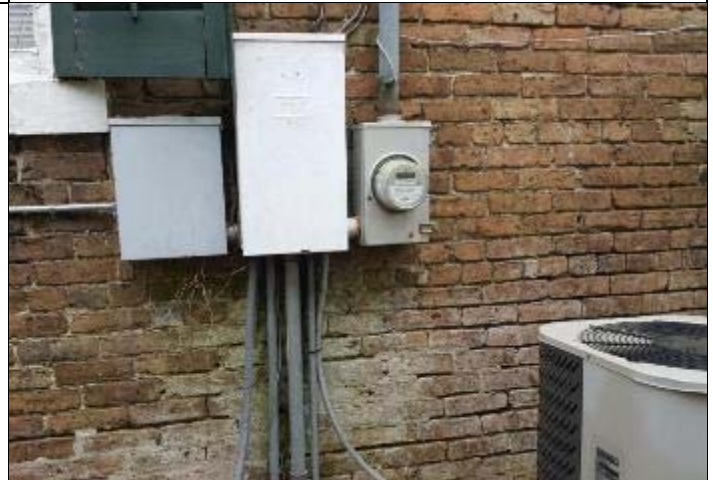
16. The main electrical service enters the Subject from a pole mounted transformer on the west side of the building to exterior switchgear.

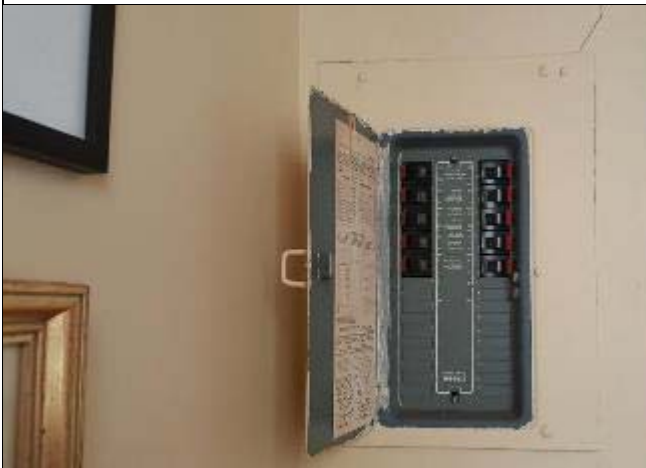
17. Distribution panels are mounted throughout the facility.

| NO. | SECTION # | DESCRIPTION | QUANTITY | UNIT | UNIT COST | OPINIONS OF COST<br>SHORT TERM | Deficiency Photo |
|---|---|---|---|---|---|---|---|
| 10 | | <b>Replace Federal Stab Lok Panels</b><br>There are two Federal Stab Lok electrical distribution panels, one at the main service wall and another in the office area. These panels are considered a fire safety hazard because there is evidence that they may not trip under load, overheating and causing a fire. While no issues were reported with these particular panels, we recommend the replacement of the panels at this time. | 2 | EA | \$500.00 | \$1,000 | |

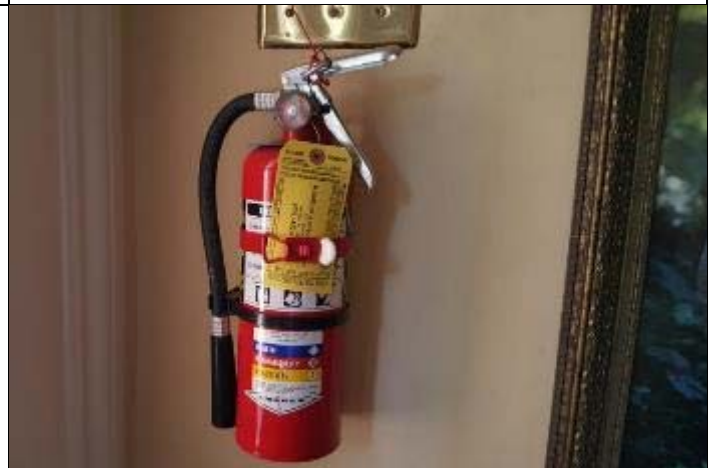
18. Wall mounted fire extinguishers are provided throughout the building.
