# FACILITY CONDITION ASSESSMENT

## City of Mobile

Facility No: 360

Traffic Engineering Office, Sign Shop,  
Warehouse & Storage Buildings

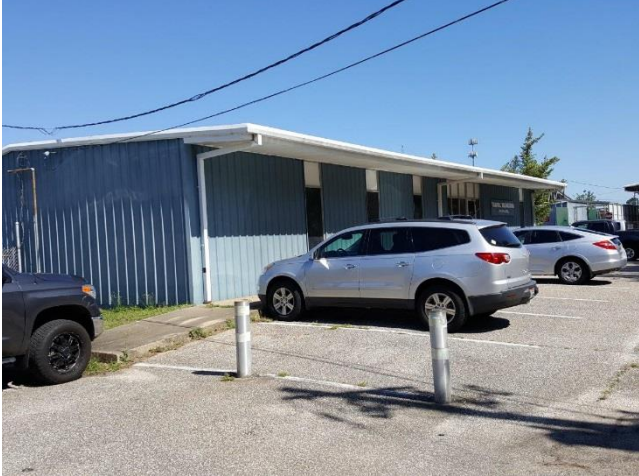
| <p>3. View of Office building.</p> | <p>4. View of Vehicle Warehouse building.</p> |

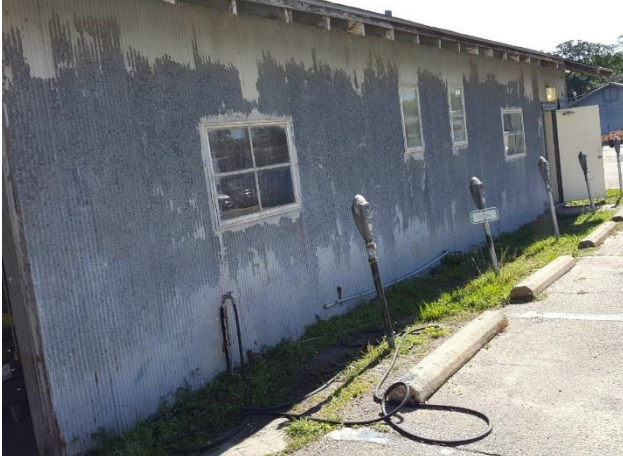
| <p>5. View of Sign Shop building.</p> | <p>6. View of Storage building.</p> |

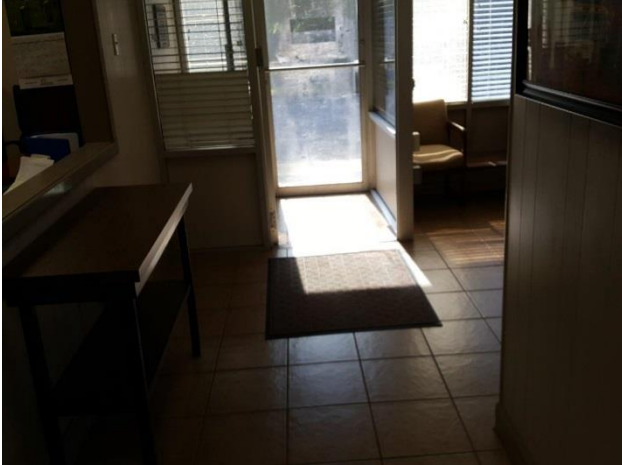
| <p>7. Office building reception interior finishes and condition.</p> | <p>8. Interior office finishes at the Office building.</p> |

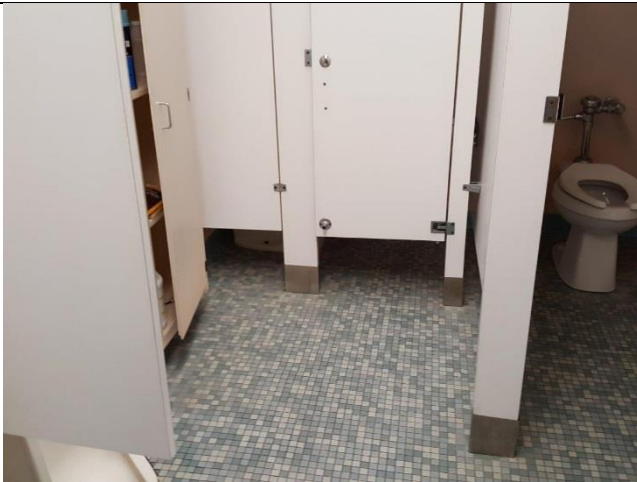
| <p>9. Toilet room interior fixtures and finishes at the Office building.</p> | <p>10. Interior finishes and condition at Sign Shop building.</p> |
